# INSPECVISION REPORT

Filepath: mm.dxf  
Customer: EMO Demo  
Operator: User Name Here  
Inspection Date: 06/09/2013 (09:20:28)  
Works Order No: 123456  
Customer Order No: 789987  
Part No: 654321  
Customer Part No: 987789  
Report Summary: Items Passed: 11  
Part Thickness: Nominal: 2

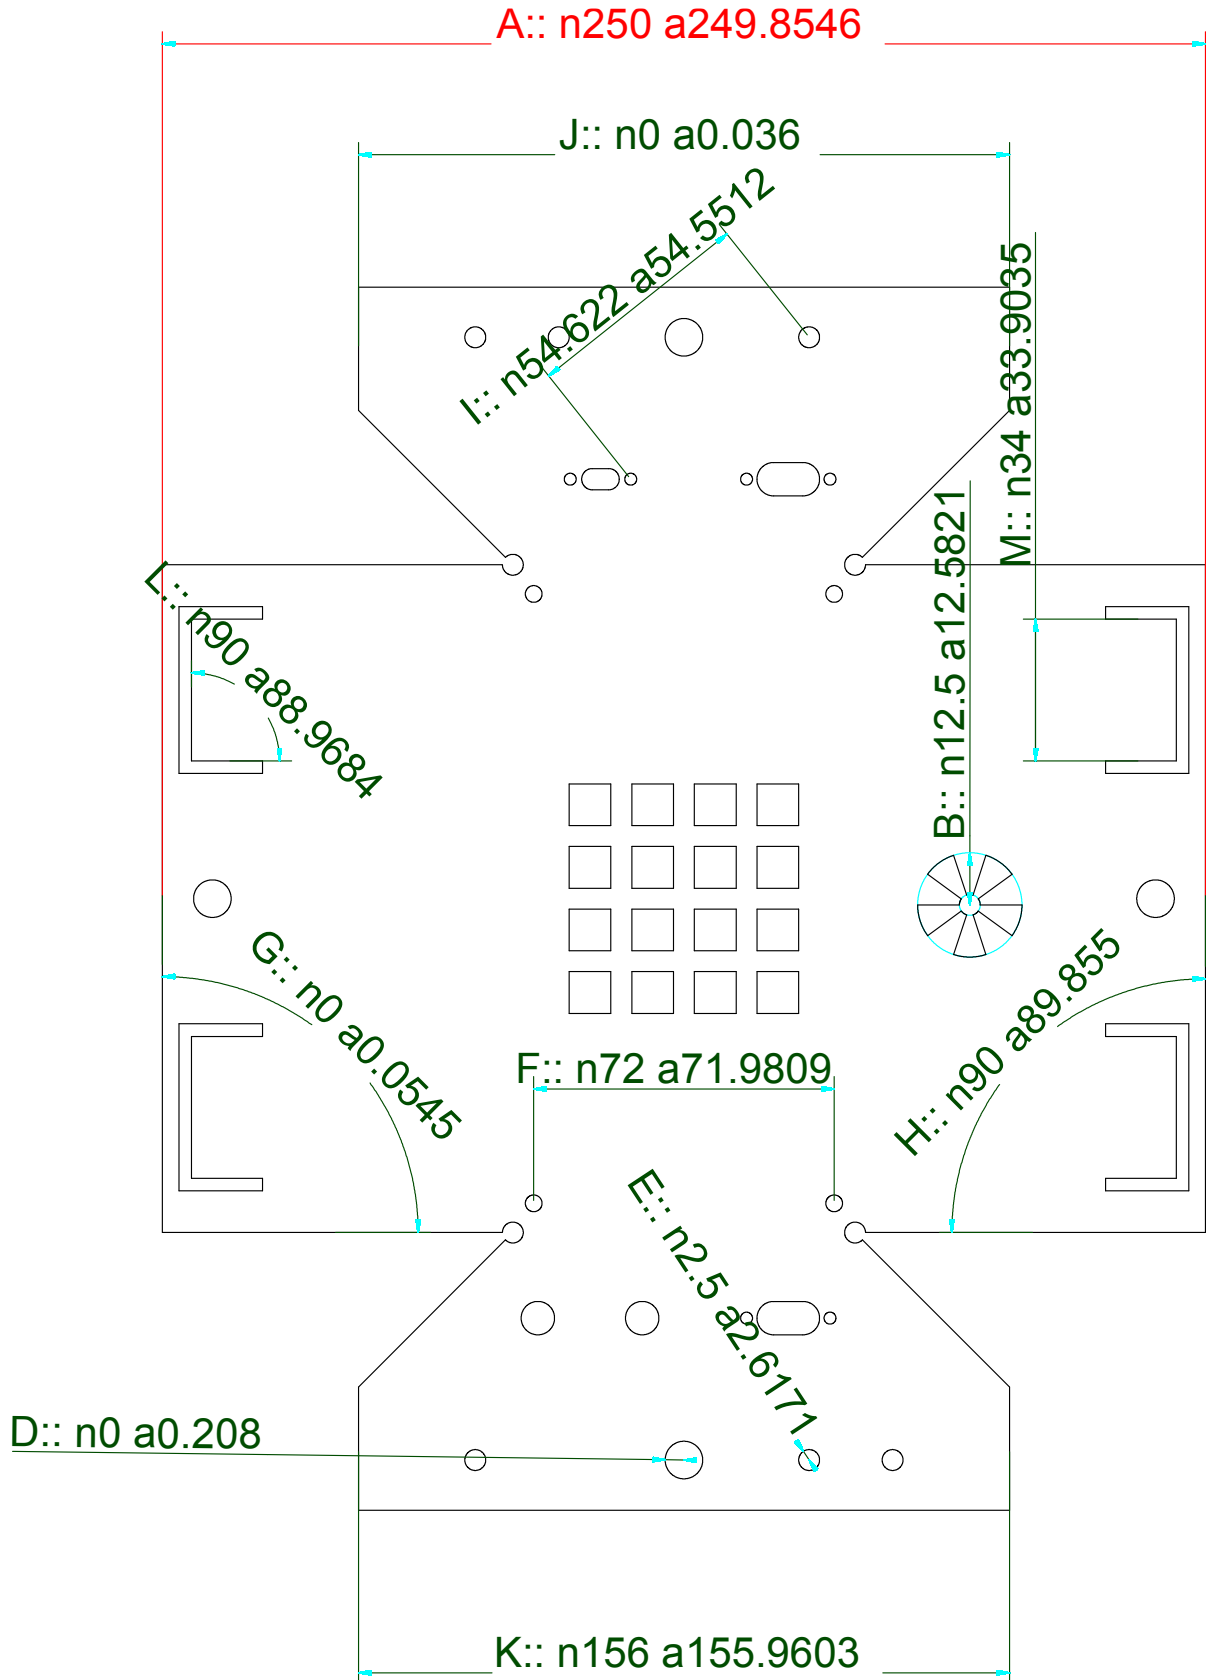
Items Failed: 1  
Actual: 2.4062

Items Missing: 0  
Deviation: 0.4062

Extra Holes: 1

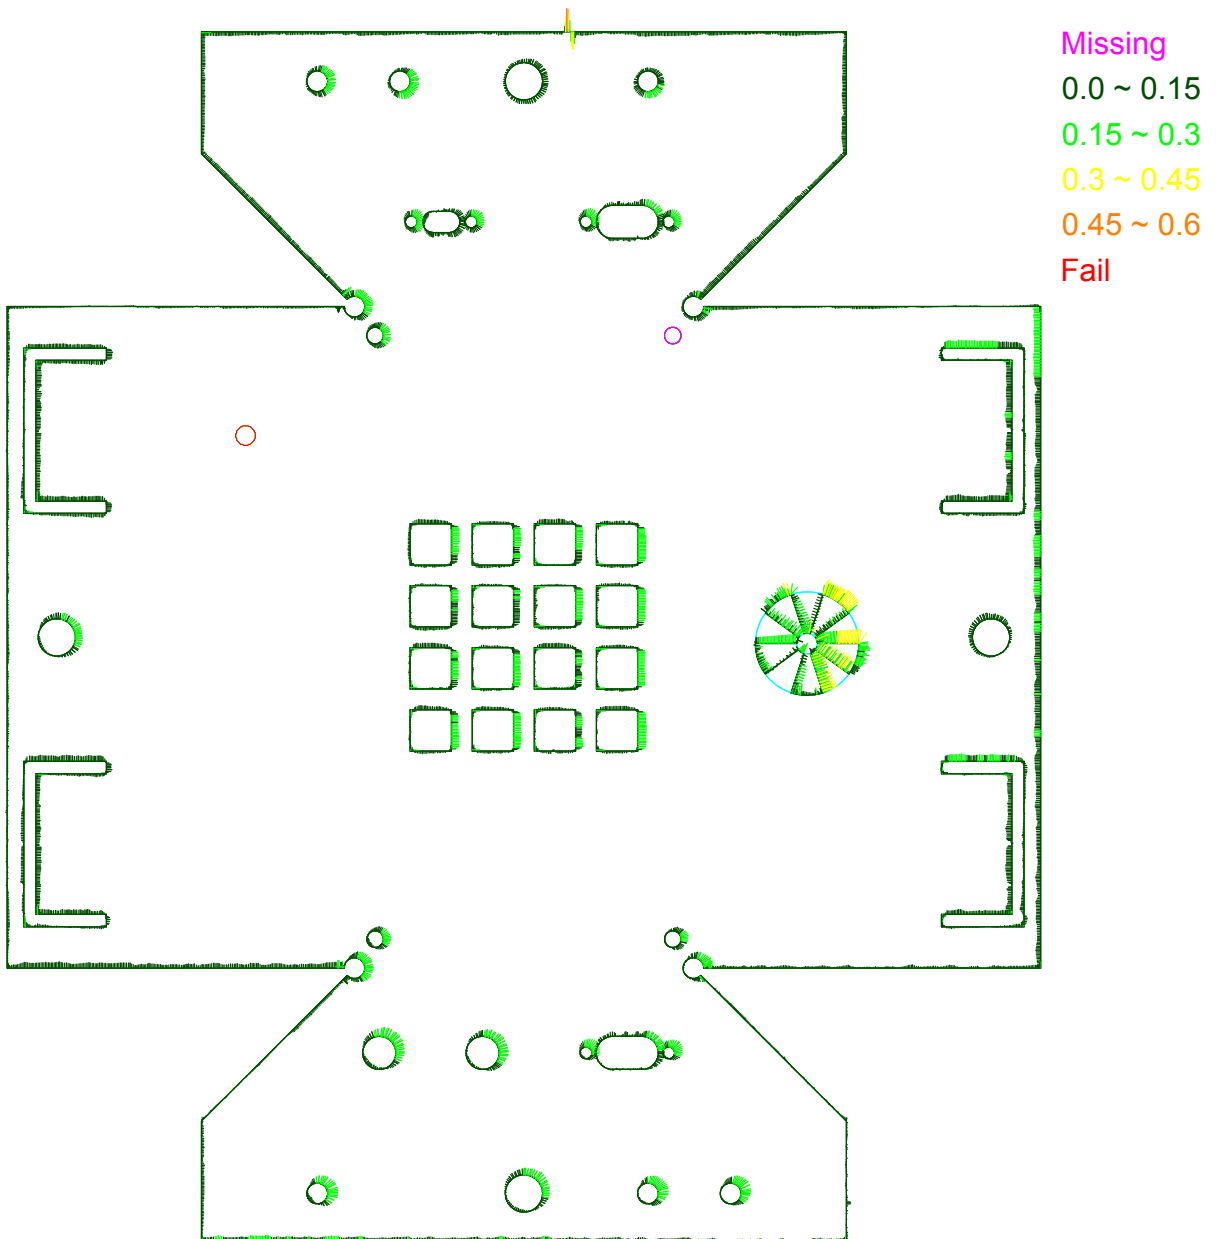
Passed: 11442  
Failed: 0  
Missing: 8  
Extra: 1  
Actual: 2.4062  
Deviation: 0.4062
